## Appendix 2

## Photographs

This appendix addresses the requirement in DoP's scope to: "provide photographs across the development site, with particular emphasis on any area for which a licence, permit or approval will apply. If water courses are impacted upon in the vicinity of the development, include photographs also looking upstream and downstream at points of geomorphic change or at distances of no greater than 500 m. A layout plan to indicate the location of the photographic reference points is to be included".

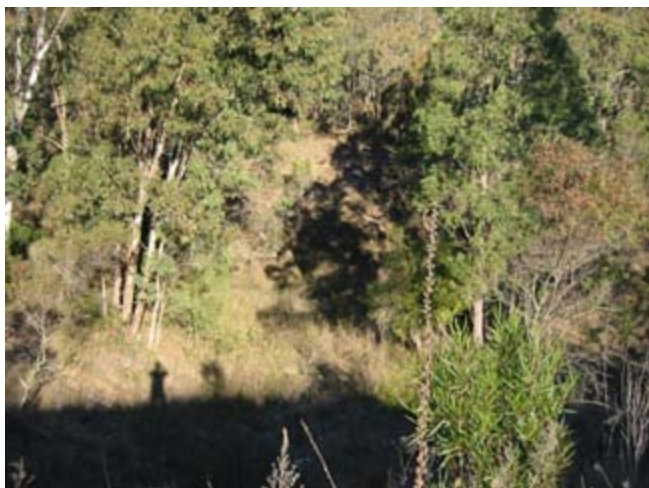
5.9 Kingdon Ponds: Minor Gully Site KP7 from road – Looking upstream  
Note right and left forks

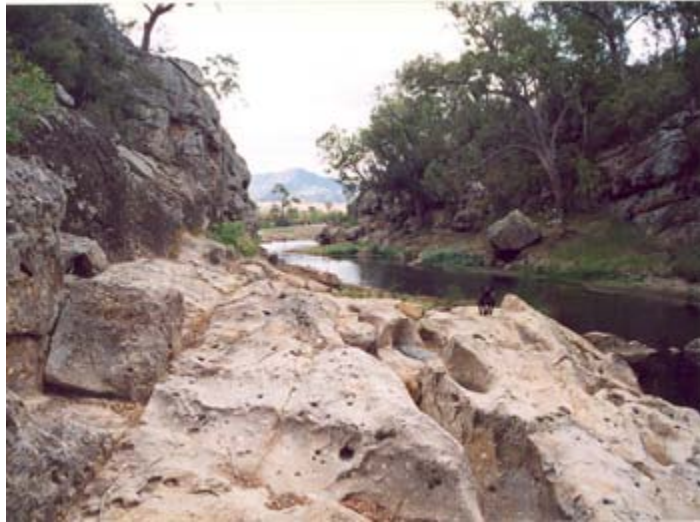
- 6.1 Bickham Gorge on Pages River looking north-west from surface water sampling location BCSW1, showing typical gorge structure with Permian hard rocks outcropping on both north and south bank

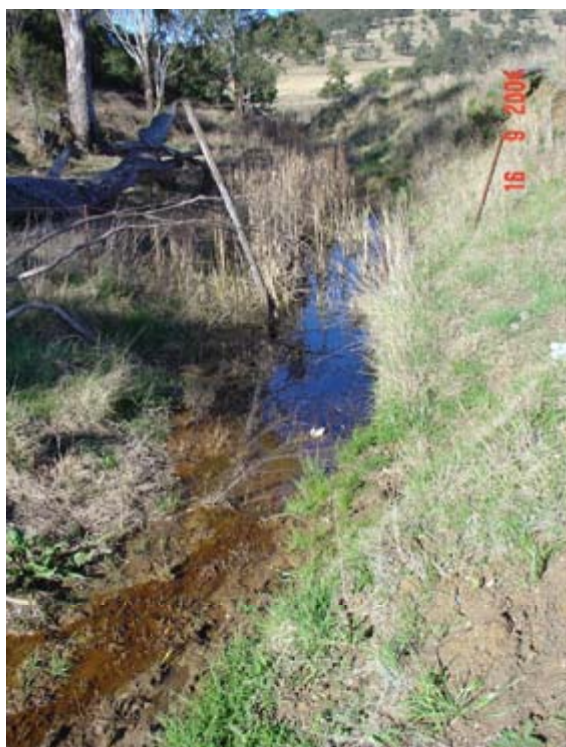
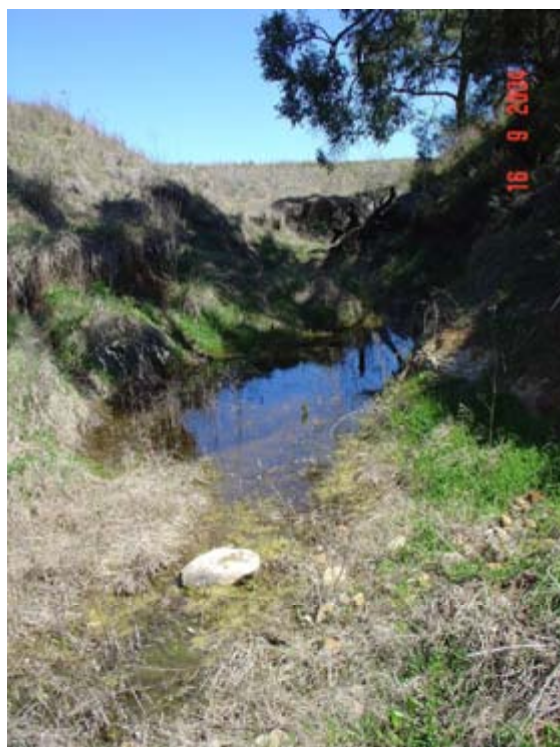
- 6.2 Seepages on tributary along northern boundary of Bickham property  
a. BCSW7 monitoring site;  
b. Pool/soak just above Pages River confluence

These photographs were taken in the northern tributary, which flows into Pages River from the west. It drains from a catchment that includes the alluvial flats upstream of Bickham Gorge, and extends across to the western side of New England Highway. The stream flows intermittently in the middle section (where monitoring sites BCSW7 and BCSW8 are situated), but there is generally no visible water in the downstream section, except periodically in isolated pools. During inspection of the above sites on 16 September 2004, water quality measurements recorded ECs of 3090  $\mu\text{S}/\text{cm}$  and 3280  $\mu\text{S}/\text{cm}$  and pHs of 8.07 and 8.13 respectively, and there was no visible discharge to Pages River.

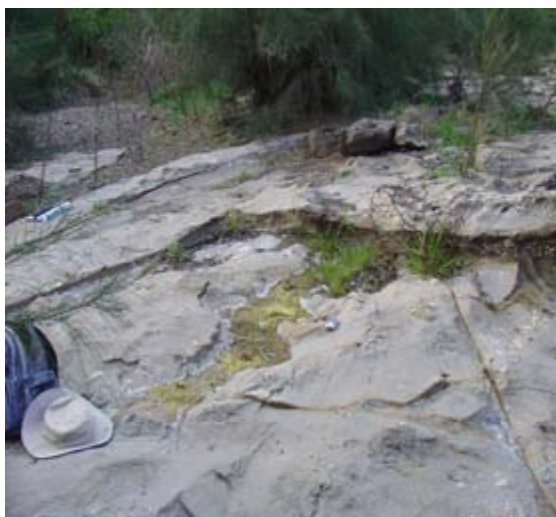
6.3 Seepage on east bank of Pages River, upstream of Bickham Gorge

Seepages just upstream from the Bickham Gorge are shown in Plates 6.3 and 6.4. The water quality of these seepages was measured on 20 September 2006 as EC 2020  $\mu\text{S}/\text{cm}$  and pH 8.45 (Plate 6.3), and EC 1868  $\mu\text{S}/\text{cm}$  and pH 7.44 (Plate 6.4).

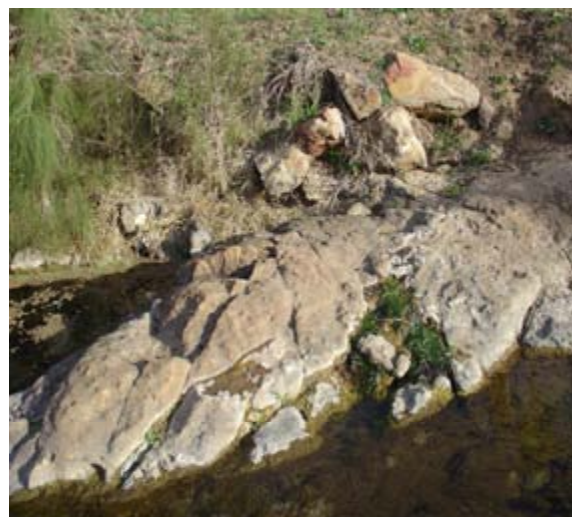
6.4 Minor seepage on west bank of Pages River, upstream of Bickham Gorge

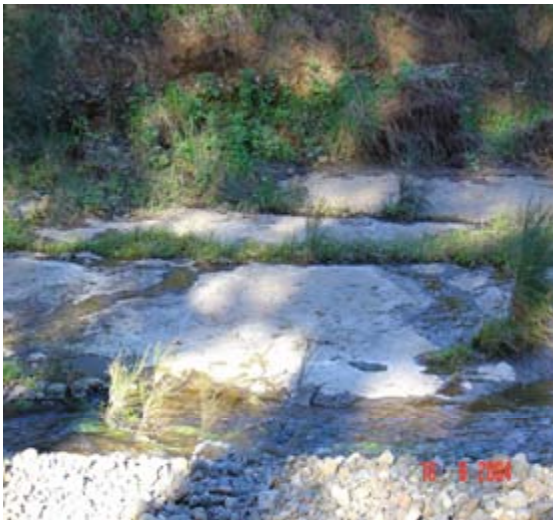
6.5 Seepage from local alluvium above Permian bedrock, on north bank of Pages River, downstream of Bickham Gorge

The seepage zone depicted in Plate 6.5 shows groundwater emerging from the base of streambank alluvium sitting on the top of Permian outcrop above river level on the north side of Pages River, downstream of BCSW1. Water quality parameters for the seepage on 16 September 2004 were measured as EC 1030  $\mu\text{S}/\text{cm}$ , pH 8.83. A similar seepage some 500m further downstream is depicted in Plate 6.6.

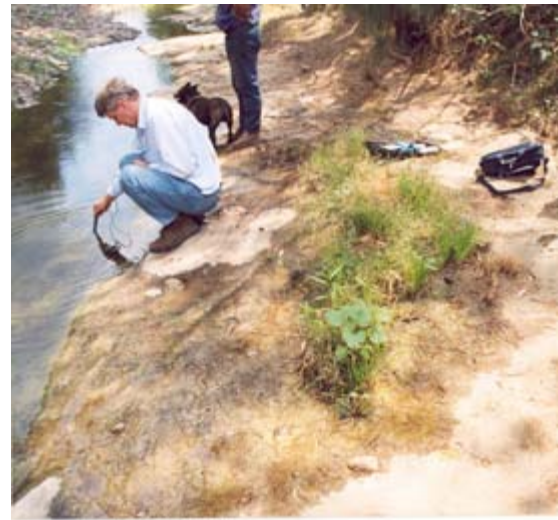
6.6 Small seepage from Permian sediments on north bank of Pages River, downstream of Bickham Gorge

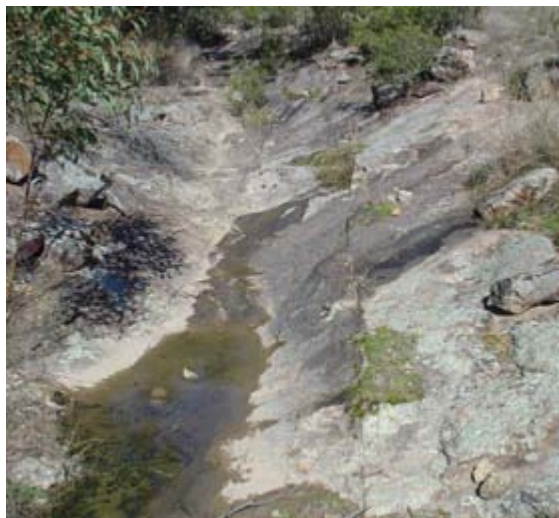
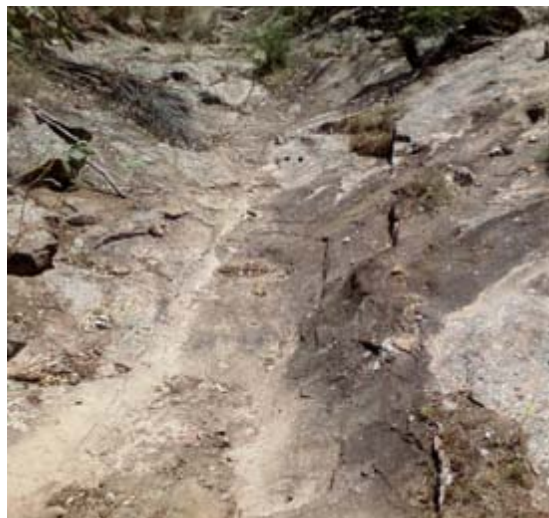
6.7

Seepage in gully below Haul Road, west of bulk sample site  
a. 1 August 2006;  
b. 11 December 2006

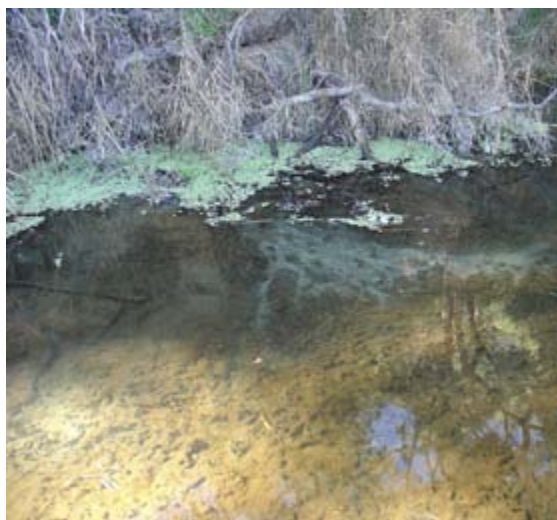
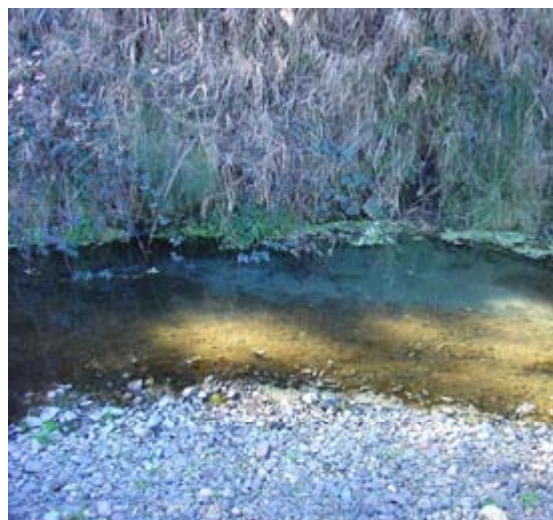
6.8 Seepages from siltstones above G Seam – north bank of Pages River. The bare patches on the river bed are caused by the high salinity and low pH of the seepage water

The seepages shown on Plates 6.8 and 6.9 are small volume seeps emerging from shales and siltstones overlying the G Seam where it outcrops on the northern bank of Pages River, north-east of the proposed mine site. The water from these seeps is saline and acidic, with measured EC of 4070  $\mu\text{S}/\text{cm}$  and pH of 4.0 when sampled on 1 August 2006. The river within the white patch below the seep had an EC of 1413  $\mu\text{S}/\text{cm}$  and pH of 8.3. The clear white patch in front of each seep is caused by seepage water fanning out across the river bed, and the high salinity and low pH inhibiting the growth of weed and algae. The area of influence by the seepages is small, as the river water has reached background EC and pH values within a few metres of the seepage entry point to the river

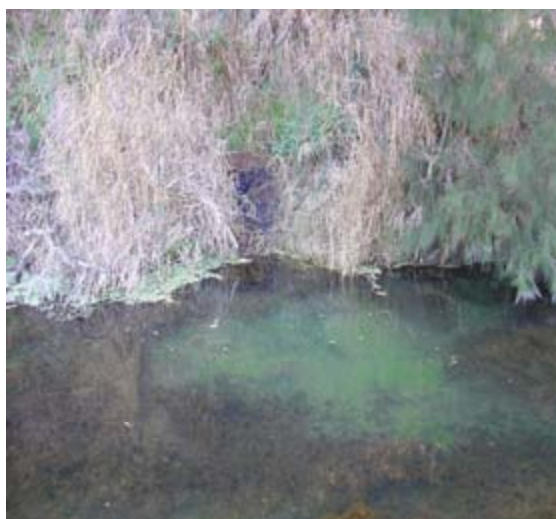
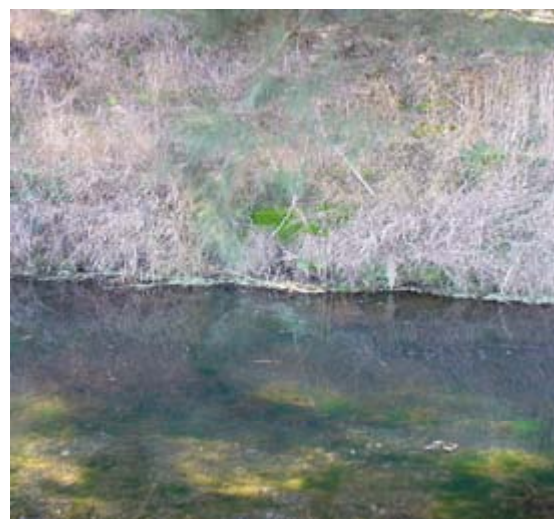
6.9 Seepages from siltstones above G Seam – north bank of Pages River. The bare patches on the river bed are caused by the high salinity and low pH of the seepage water

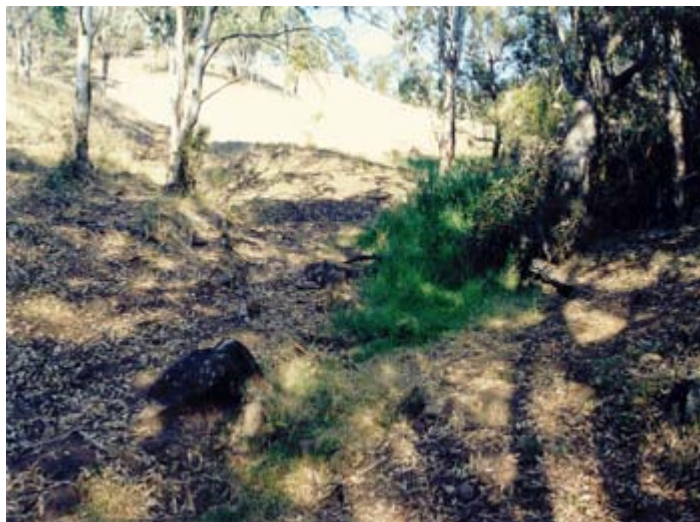
6.10 Area of lush grass at base of gully below bulk sample overburden dump, 50m above Pages River confluence

Periodically, seepages are also visible in places along the gully below the former flint clay quarry which was rehabilitated during the bulk sample project. At the downstream end of the gully, no seepage has been observed, but there is a lush growth of grass indicating the presence of water close to the surface (Plate 6.10). The highest point of visible seepage within the gully is close to the subcrop line of the base of the Koogah Formation. The seepage does not reach Pages River, as it is lost to evapotranspiration before reaching river level.
